Manhole Inspection Summary

Manhole # S47W1_004MH

Insp Date: **3/30/09 4:50 PM**

Location Address: **1300 Child St.**

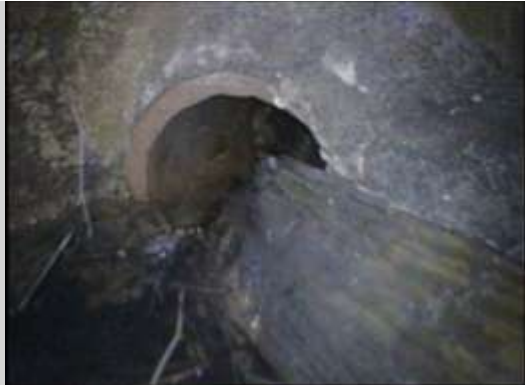
12 O'Clock Outflow

10 in. Circular Gravity Sewer
Pipe Out @ 12 O'Clock

Pipe Height: **10.8** (in.) Rod and Bar (Angled)
Pipe Material: **Clay** ☐ Pipe Lined
Invert Depth: **13.00** (ft.) Flow Characteristics: **Slow**
Deposits: ☐ None ☐ Mud ☐ Gravy ☒ **Debris** ☐ Grease
Silt Depth: **6** (in.) Deposits Extent: **Heavy**
Infiltration: **None** Pipe Seal Cond: **Sound**

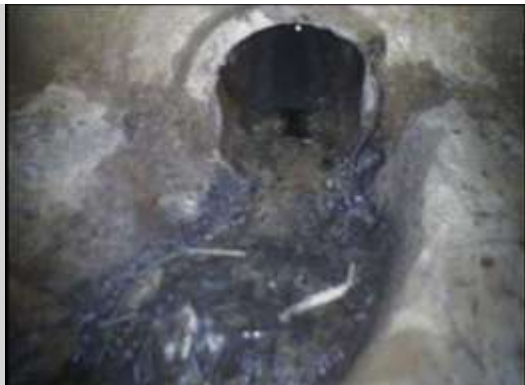
3 O'Clock Inflow

8 in. Circular Gravity Sewer
Pipe In @ 3 O'Clock

Pipe Height: **8.4** (in.) Rod and Bar (Angled)
Pipe Material: **Clay** ☐ Pipe Lined
Invert Depth: **12.50** (ft.) Flow Characteristics: **Slow**
Deposits: ☐ None ☐ Mud ☐ Gravy ☒ **Debris** ☐ Grease
Silt Depth: **6** (in.) Deposits Extent: **Heavy**
Infiltration: **None** Pipe Seal Cond: **Sound**

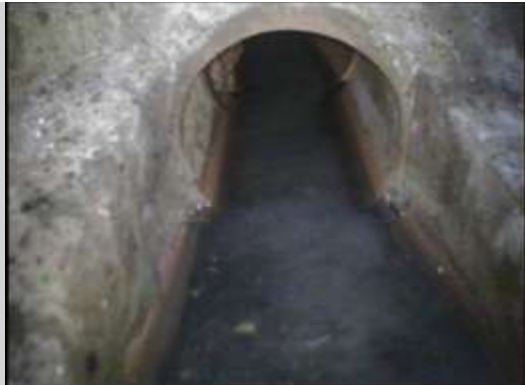
6 O'Clock Inflow

8 in. Circular Gravity Sewer

Pipe In @ 6 O'Clock

Deposits: ☐ None ☐ Mud ☒ Sludge ☒ Debris ☐ Grease

Silt Depth: **6** (in.) Deposits Extent: **Heavy**

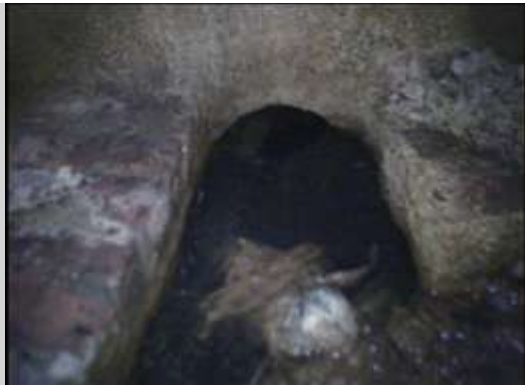
9 O'Clock Inflow

8 in. Circular Gravity Sewer

Pipe In @ 9 O'Clock

Deposits: ☐ None ☐ Mud ☐ Sludge ☒ Debris ☐ Grease

Silt Depth: **8** (in.) Deposits Extent: **Heavy**
